PROJECT REPRESENTATIVE S DAILY REPORT

Pg. 1
Report No. 088
Date: 2014-12-23
Day: Tuesday

Project: Renovation and Addition to Tewksbury Town Hall

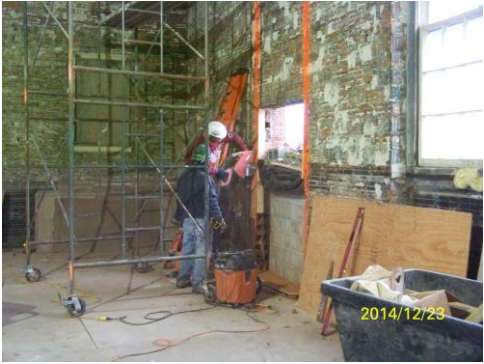
<p>Photo showing masons cutting the masonry opening on the north elevation of the meeting hall. This is being done to accommodate the new window.</p>

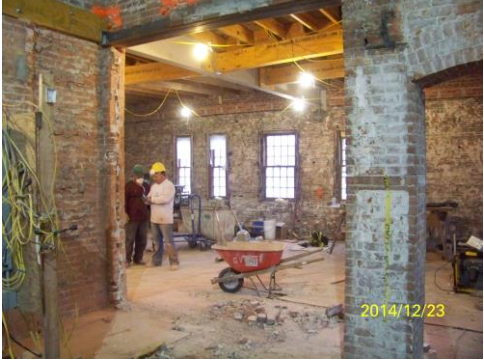
<p>Photo showing wall removed on the 1st floor at the location for the service counter.</p>

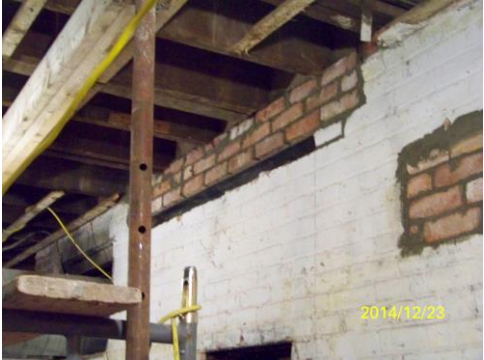
<p>Photo showing lintels installed in the basement for a new masonry opening.</p>

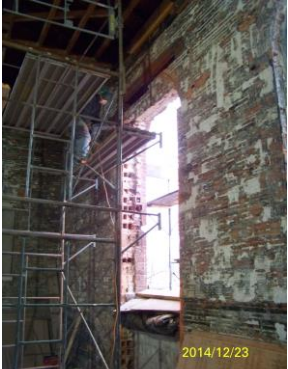
<p>Photo showing mason removing masonry for the new window opening.</p>

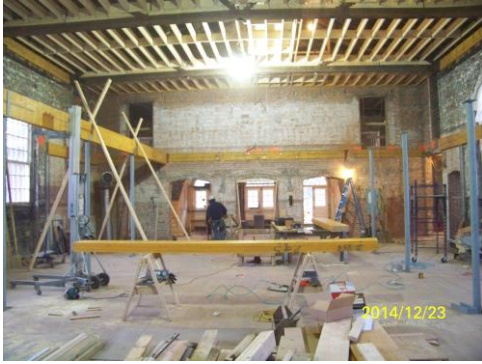
Photo of the meeting hall looking east showing the 2nd floor framing installation in progress.

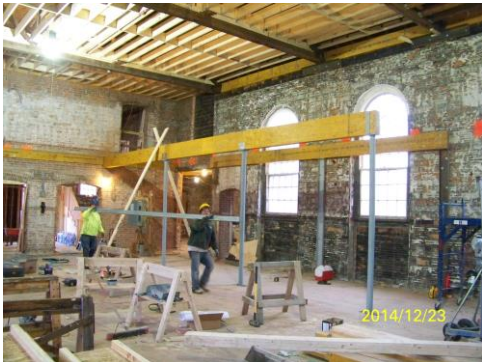
Photo showing 2nd floor framing along southeast corner of the meeting hall.

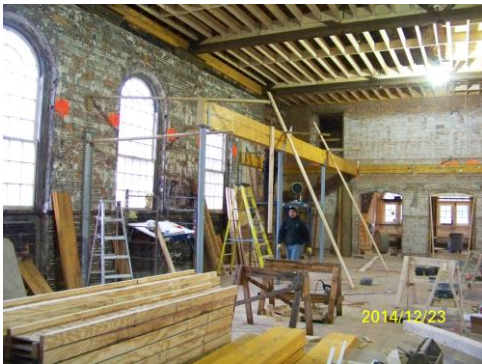
Photo showing 2nd floor framing in progress in the northeast corner of the meeting hall.

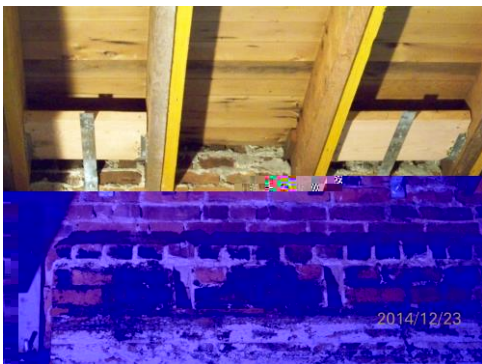
Photo showing tie-backs in place on the north elevation of the north wing. This is a typical installation.

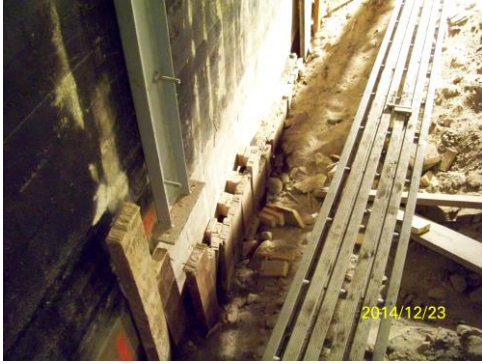
Photo showing sheathing planks in place at the underpinning location. These are in place to mitigate undermining of the basement subfloor.

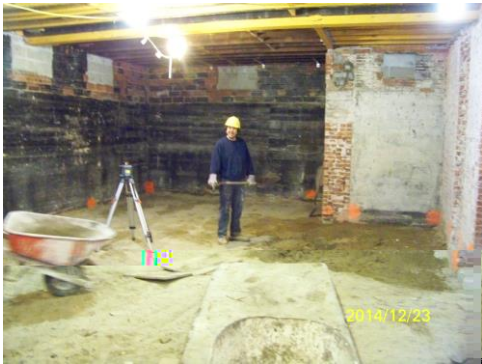
Photo showing workman in the process of prepping the basement subfloor in the north wing of the basement.
